Inspection Report Minerals Regulatory Program Report Date: October 21, 2004

Mine Name: Seep Ridge

Permit number: M/047/002

Inspection Date: October 18, 2004

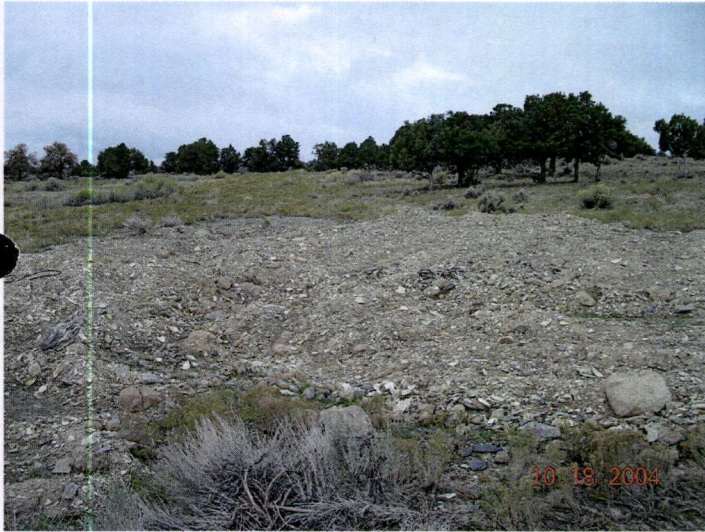
During the July inspection, we tried to find the well that was used to supply water for the trailer park. The hole that was dug as part of the search had been filled in (Photo 1).

Photo 1. The area that was dug up last July looking for the water well in the trailer park.

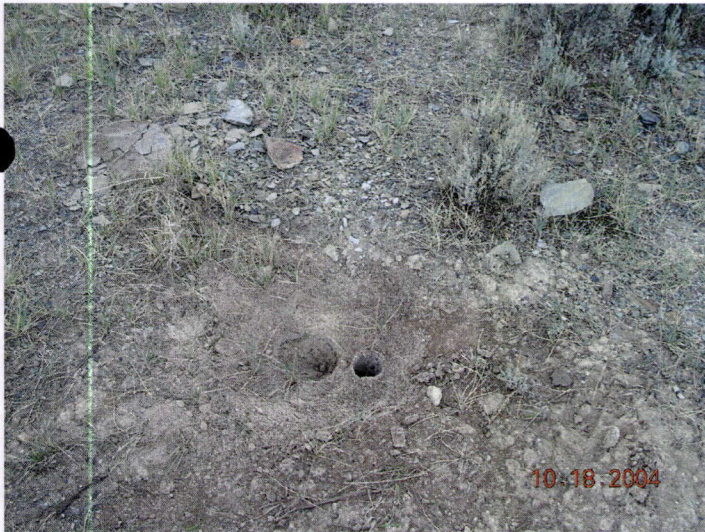
To the west of the trailer park, we found two cased drill holes (Photo 2). The larger of these holes (about 4 inches in diameter) was filled with dirt as far as we could see, but the smaller hole was not. While I do not know who drilled these holes or what the purpose was, I do not believe this was the location of the water well for the trailer park. The water right legal description, maps in the plan, and an aerial photo all indicate the trailer park well was in the area where we looked last July.

Photo 2. Two cased holes to the west of the trailer park.

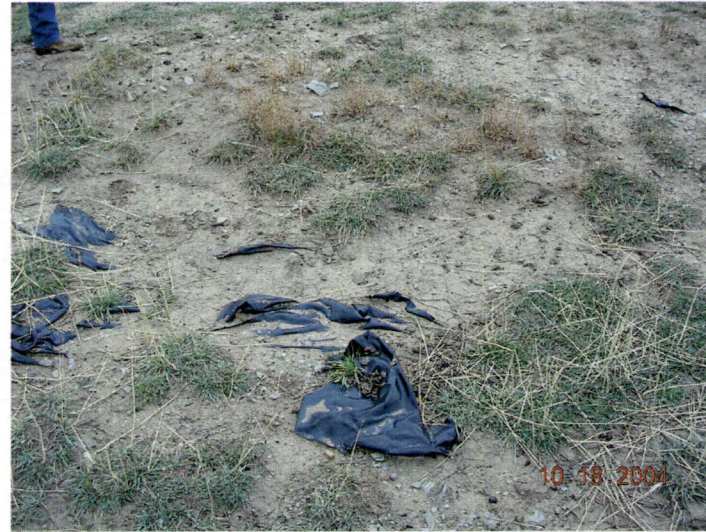
In the area of the ponds, we found some old hypalon liner (Photo 3). It appeared this liner had originally been buried but that it surfaced over the years. Mr. Jensen is familiar with this type of material and said it will photodegrade with time.

Photo 3. Hypalon liner that has surfaced at one of the ponds.

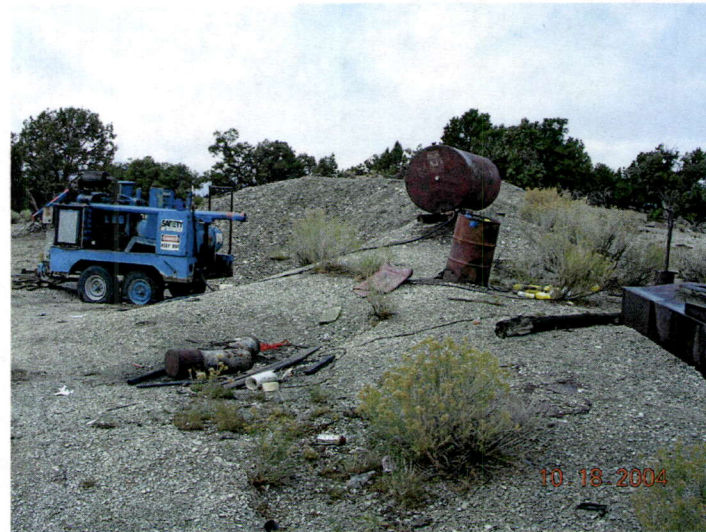
There was a lot of trash around the operating water well (Photo 4), but this is not the operator's responsibility. This photo does not show nearly all of the garbage. The compressor was running while we were at the site.

Photo 4. The operating well. Note the amount of trash; there is more nearby.
